Durability Project Mineral wool

Report on findings E3.3-2016/01

Subject: Durability Project Mineral wool

Report No.: E3.3-2016/01

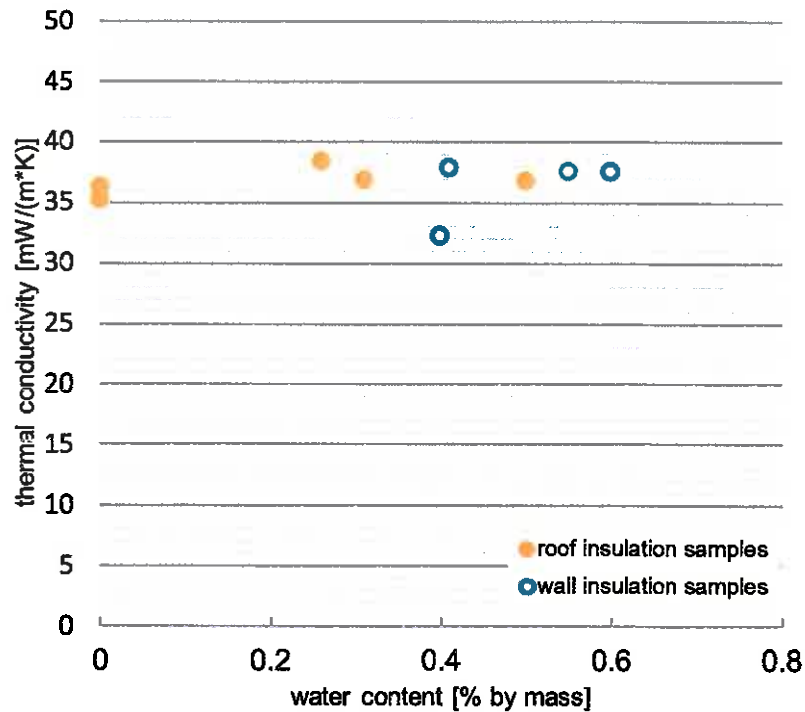
Figure 2: thermal conductivity vs. water content by mass of the thermal conductivity samples at the time of testing.

Figure 2 shows all measured thermal conductivity values for both applications as a function of the samples' water content. The differences in measured moisture content did not show significant impact on thermal conductivity. This demonstrates that both the water content in the constructions was inconsequential for the thermal properties and the sensitivity of the thermal performance of mineral wool to moisture in the expectable range for faultless constructions is very low.

The moisture content of all samples was within the limits of below 1.0 % by mass. The samplings showed no problems with decay in the roof or wall constructions due to excessive moisture or mold in any case, even though the water repellent characteristics of most samples did not meet today's requirements for brand-new mineral wool insulation products in building applications at time of delivery.

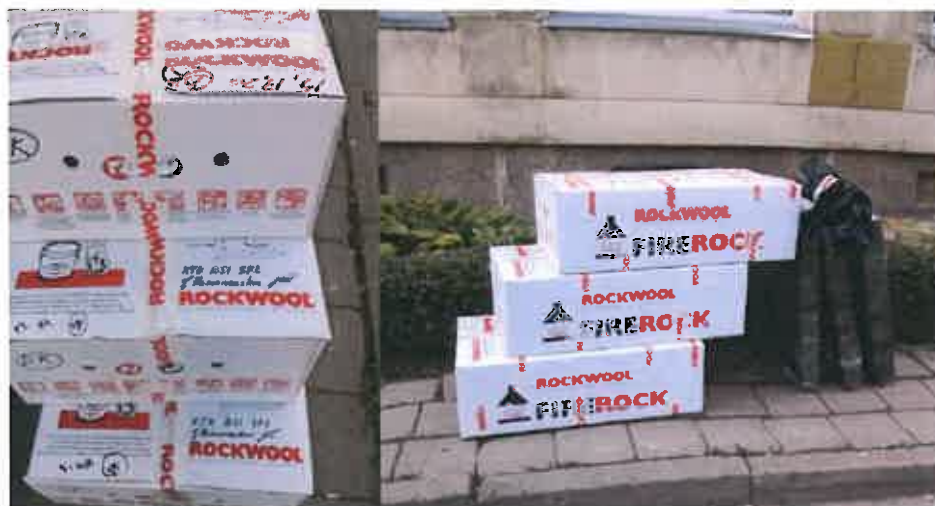
Figure 8. The samples packed into carton boxes for sending to the laboratories. The boxes signed for representative of laboratory
